ANNUAL MEETING OF THE INTERNATIONAL SCIENTIFIC COMMITTEE ON HISTORIC CITIES, TOWNS AND VILLAGES
(CIVVIH) – ICOMOS

LIVING HERITAGE :
DISASTER MANAGEMENT

THE VILLAGE OF VRISSA ON LESBOS, GREECE A CASE STUDY ON FAILED MANAGEMENT OF A HERITAGE SITE POST-EARTHQUAKE

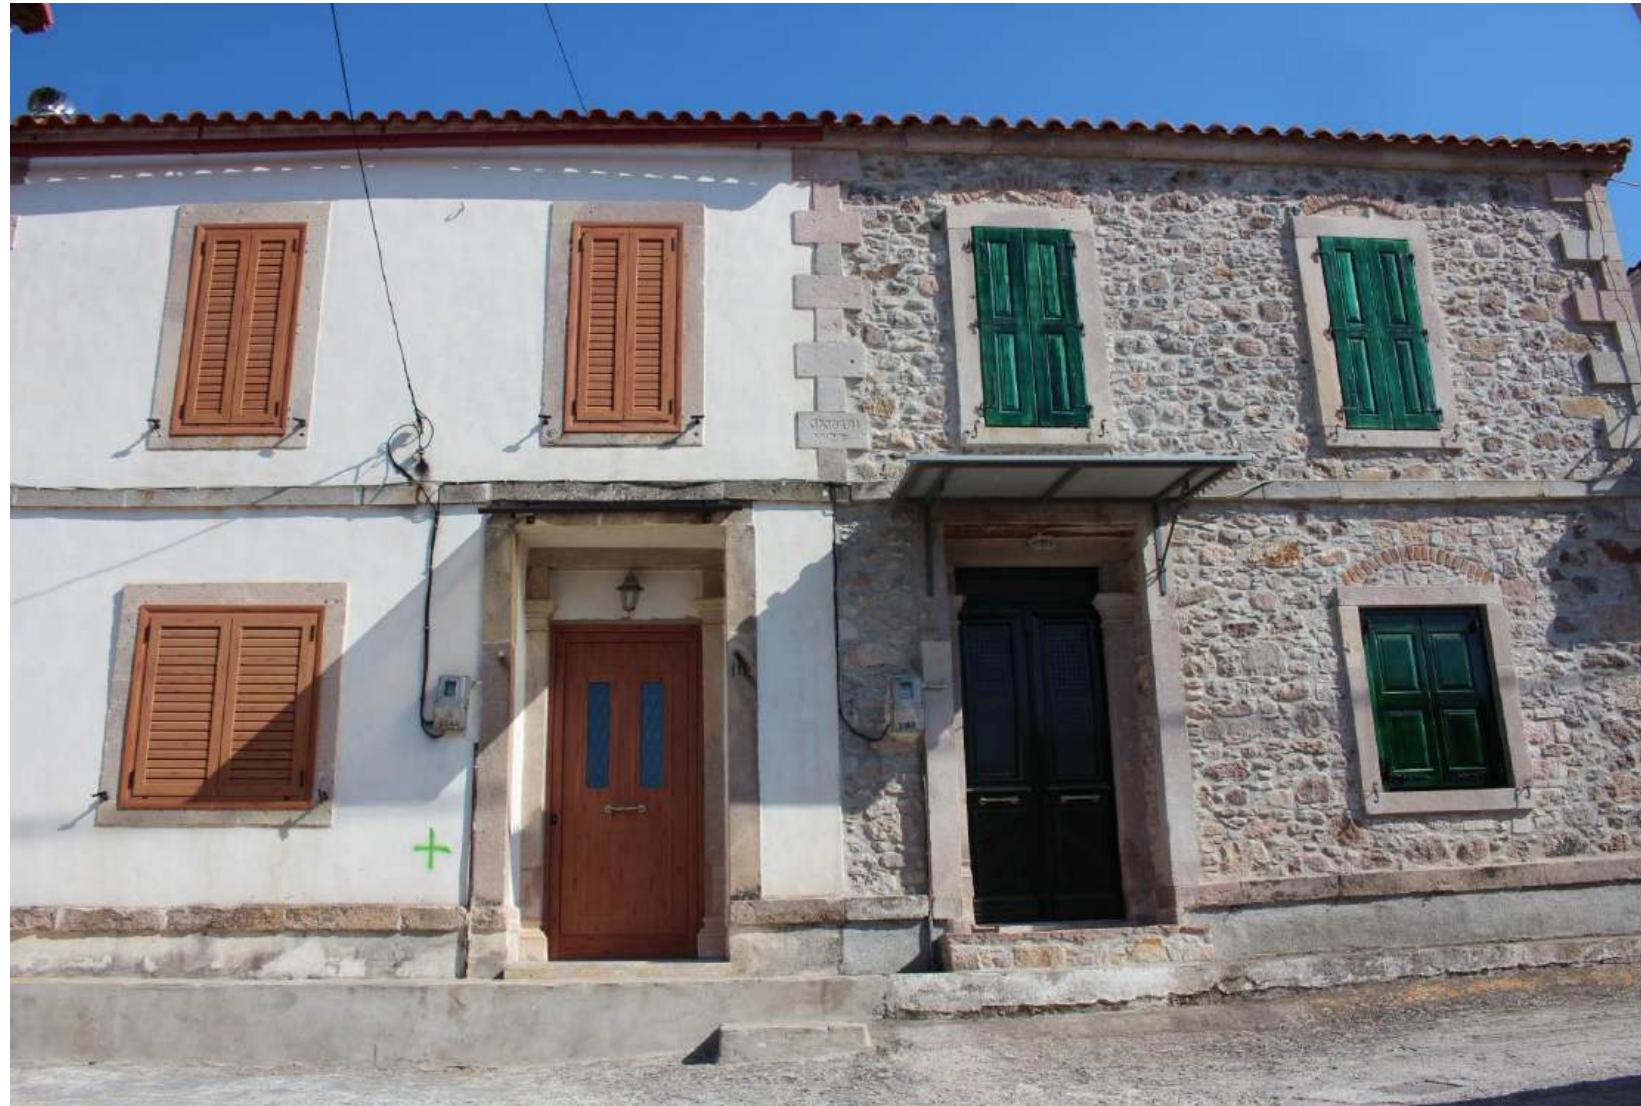
Suvelikia:
the traditional carved stone
frame of doors and windows.

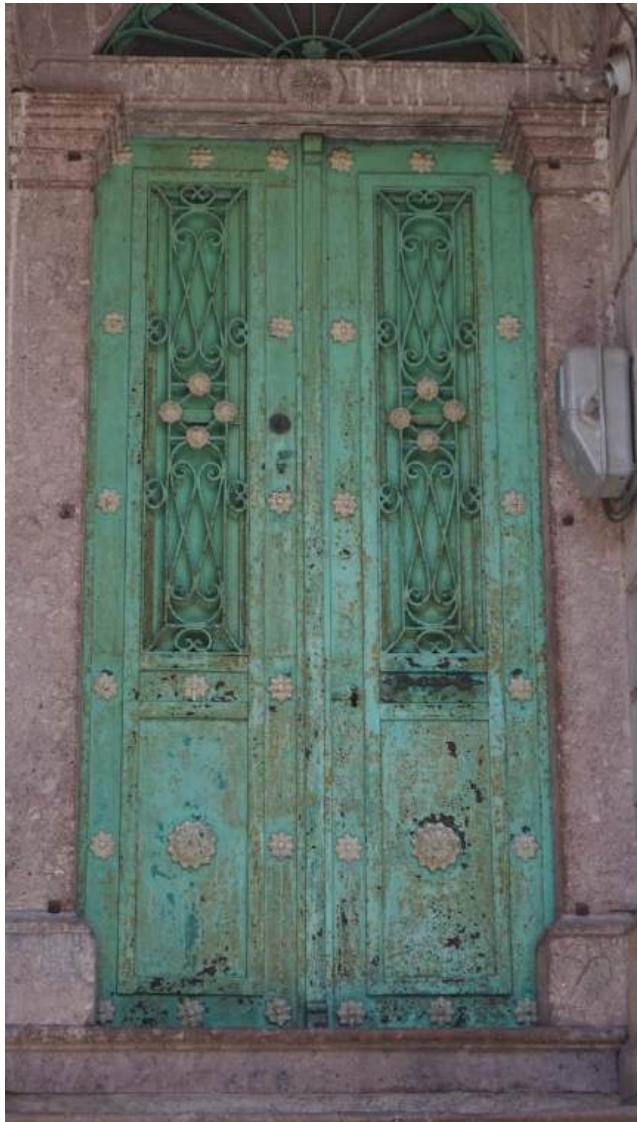
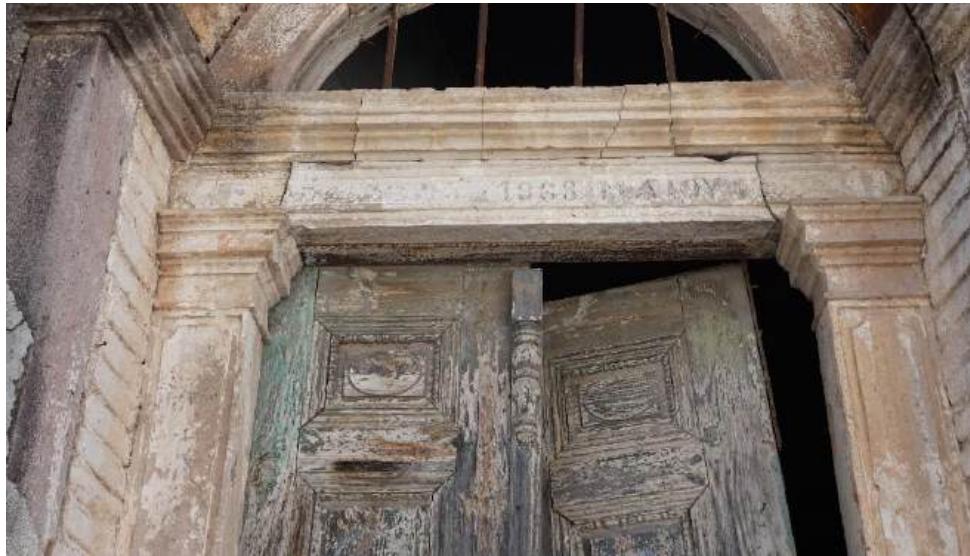
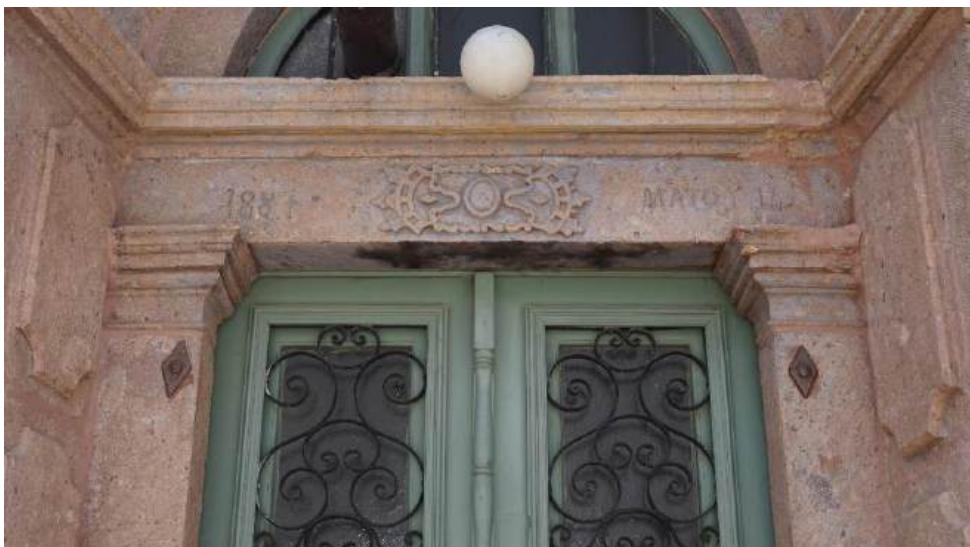
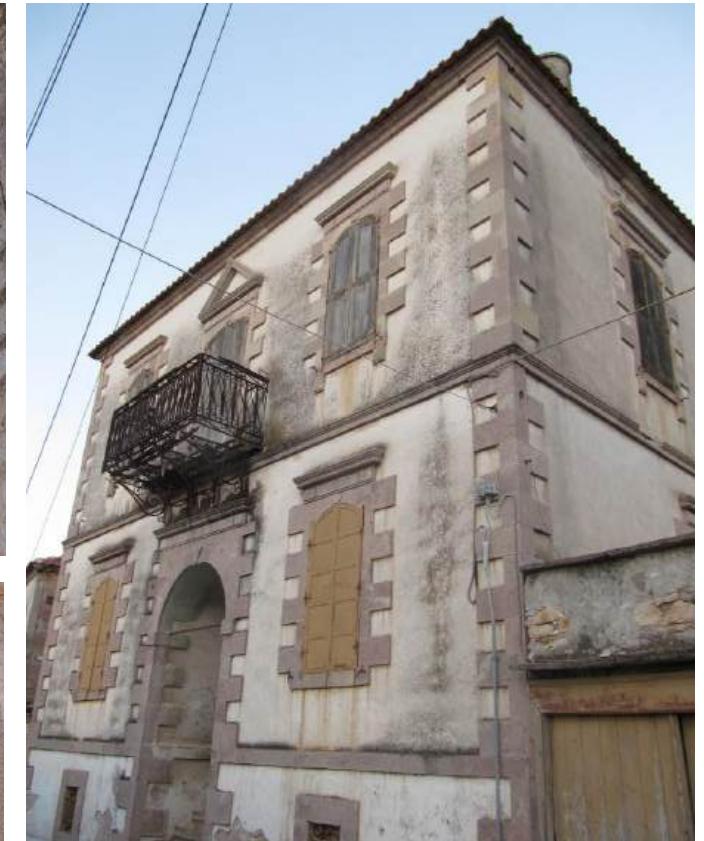
Suvelikia:
the traditional carved stone
frame of doors and windows.

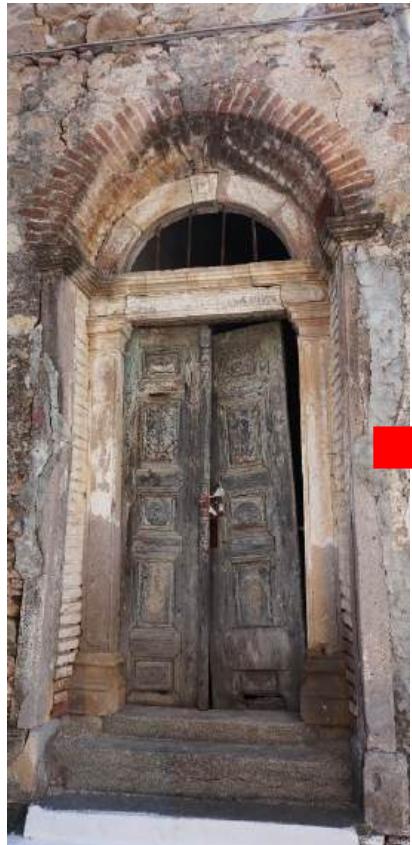
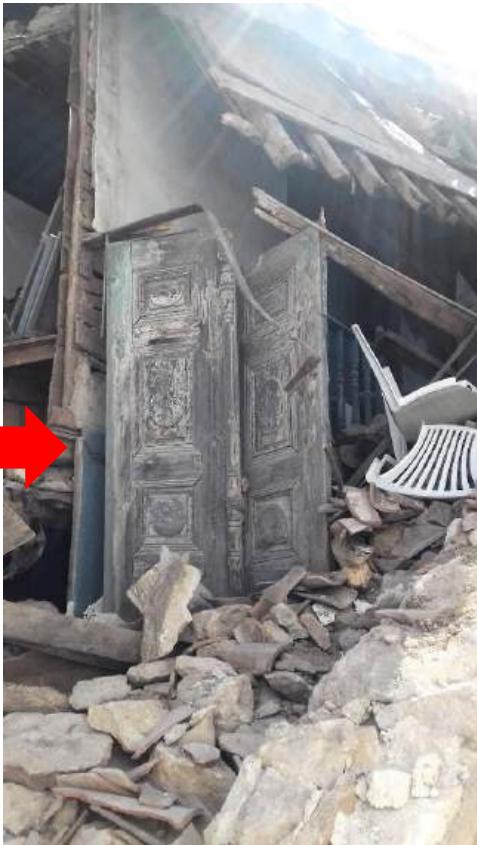
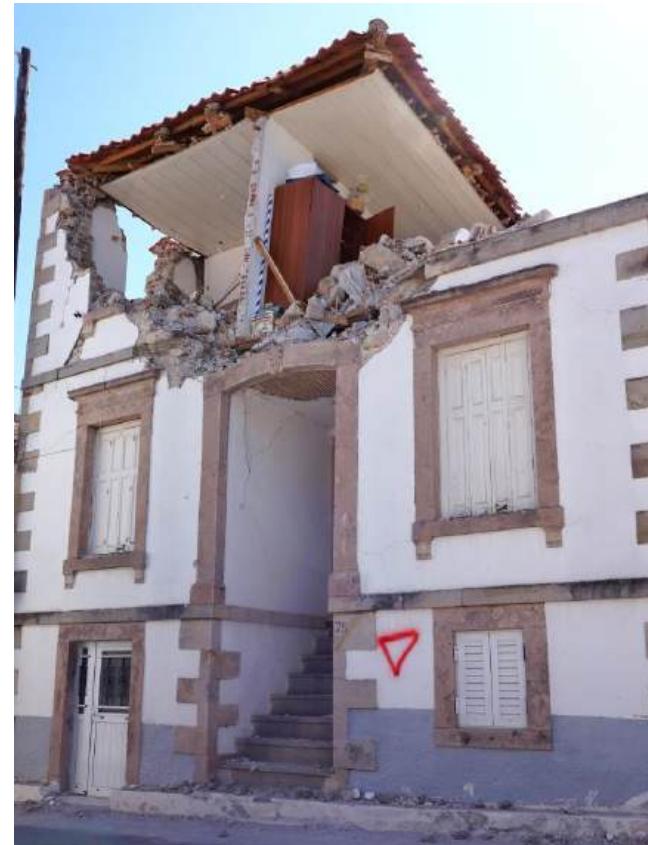
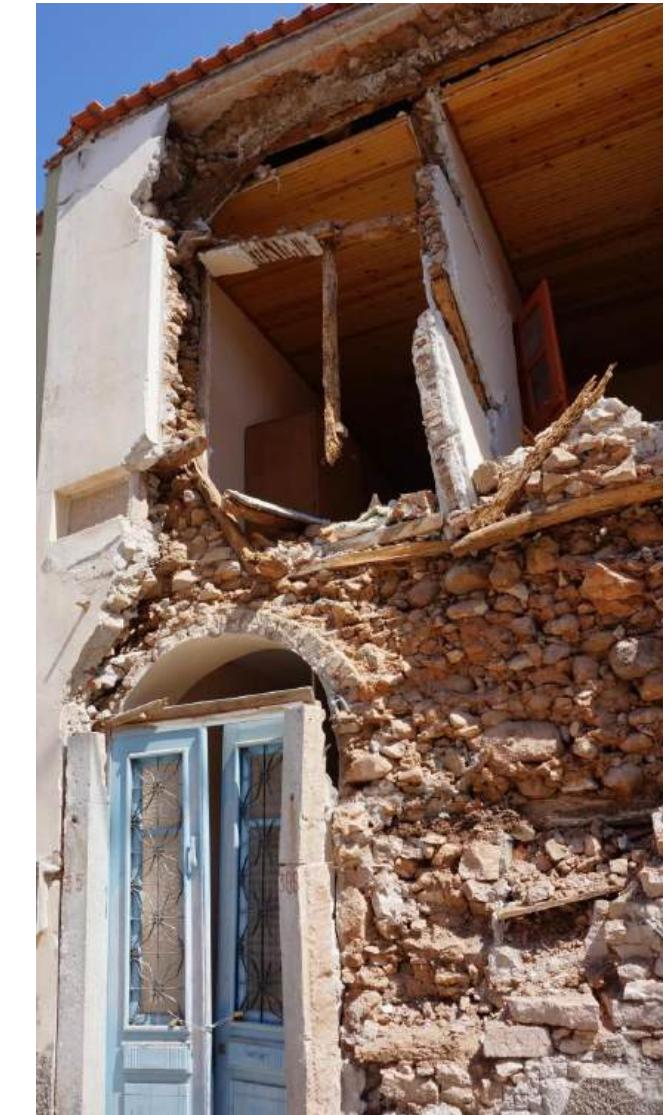
In Vrissa, **268** buildings had to be torn down
Out of a total of approx. 700 village buildings

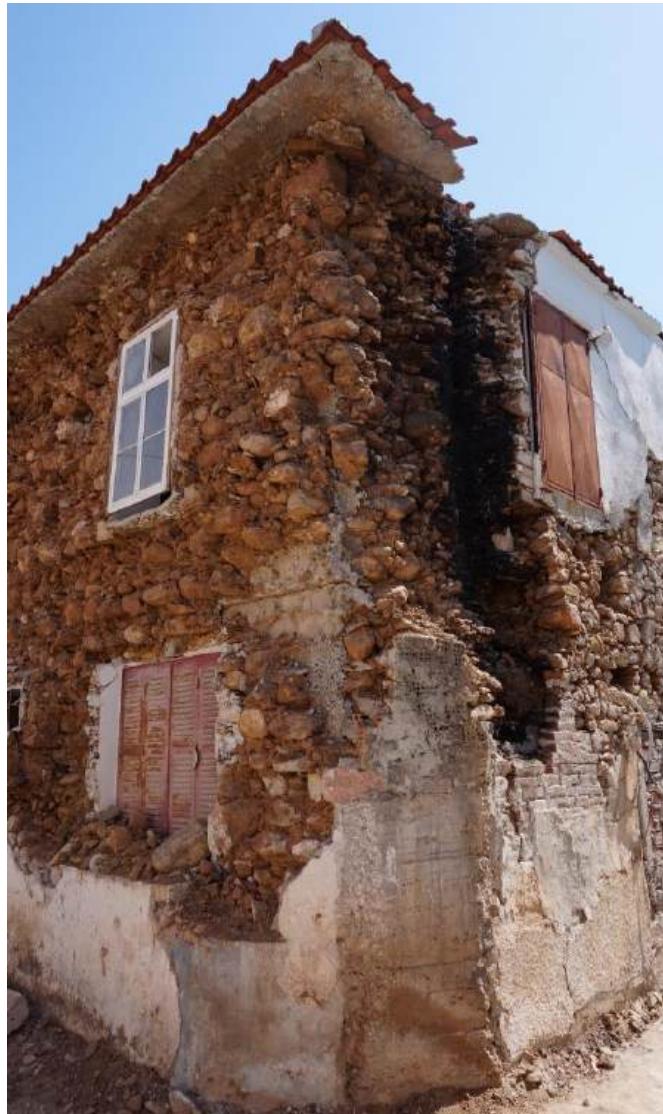
Stonemasonries using rounded stones
from the river-bed and clay

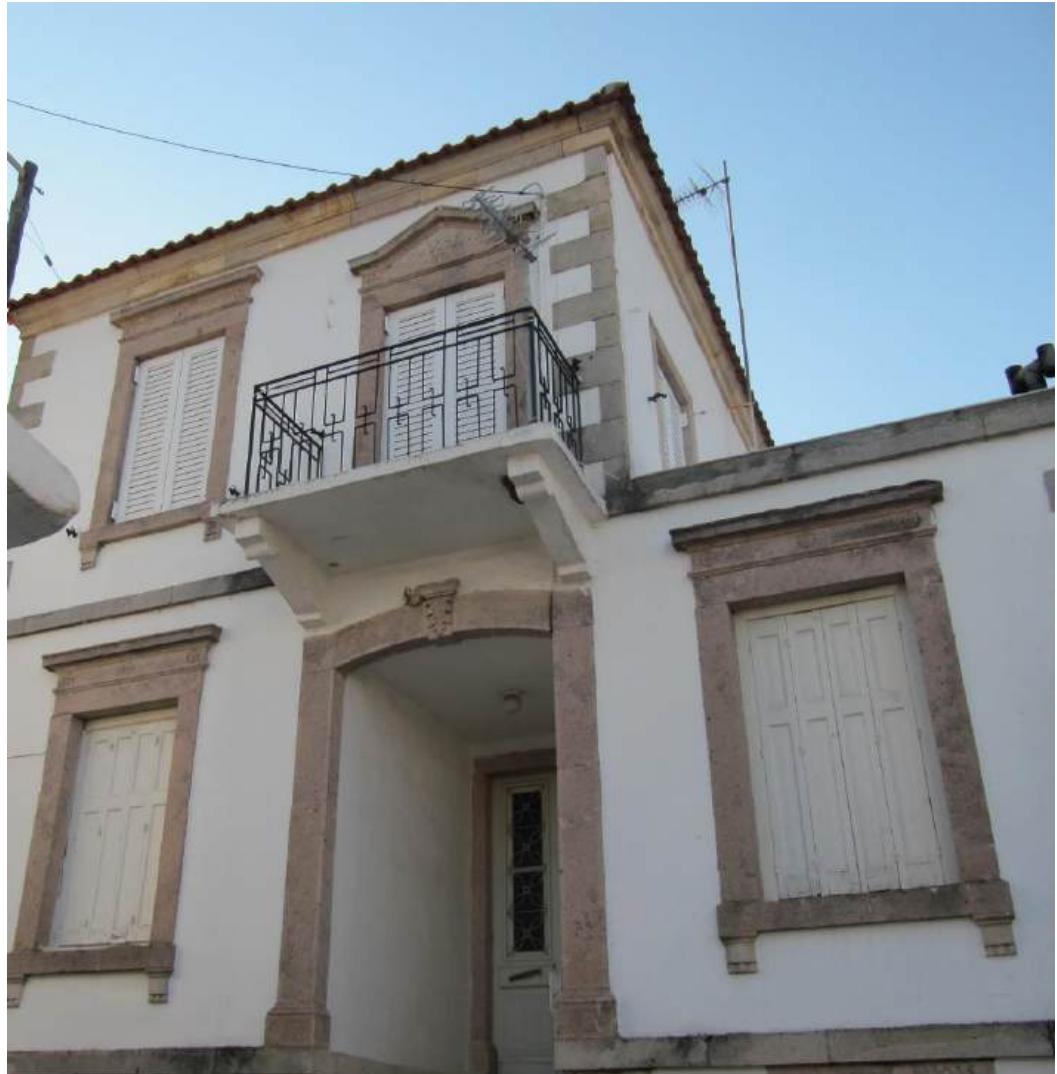
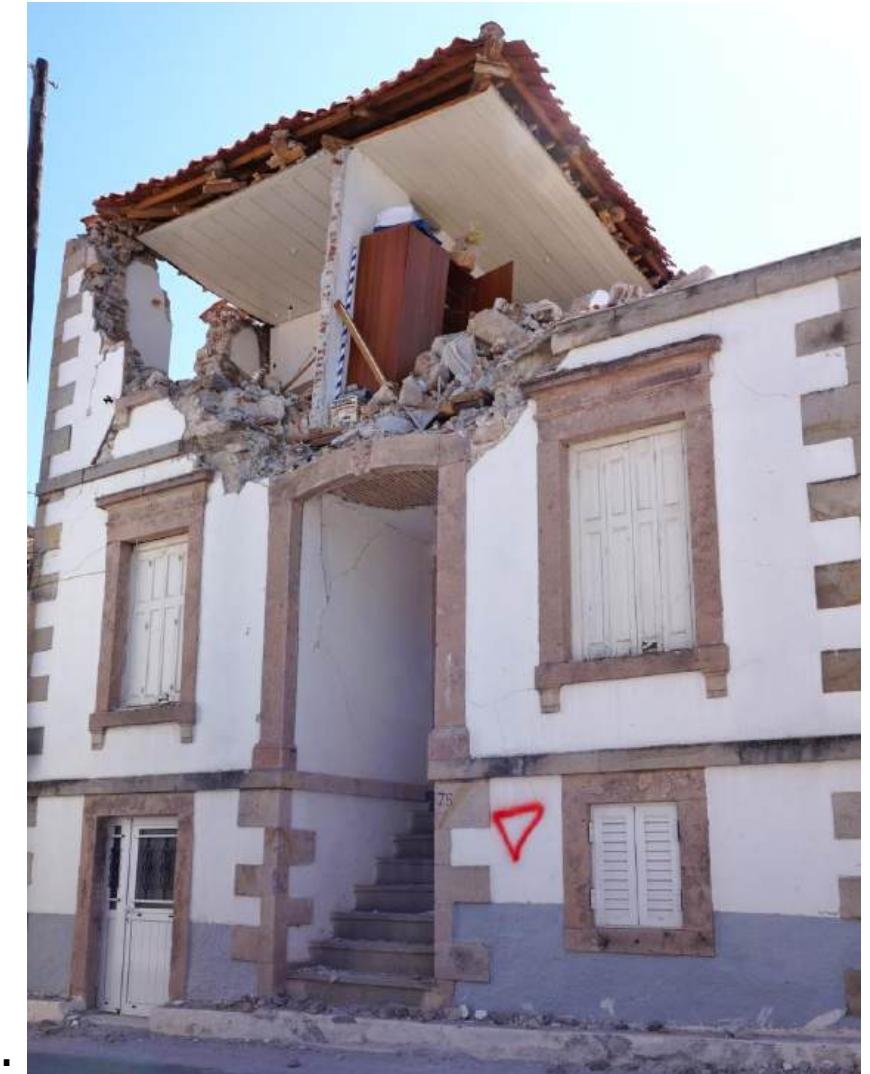
Concrete balconies
rammed the top
floor of the houses.

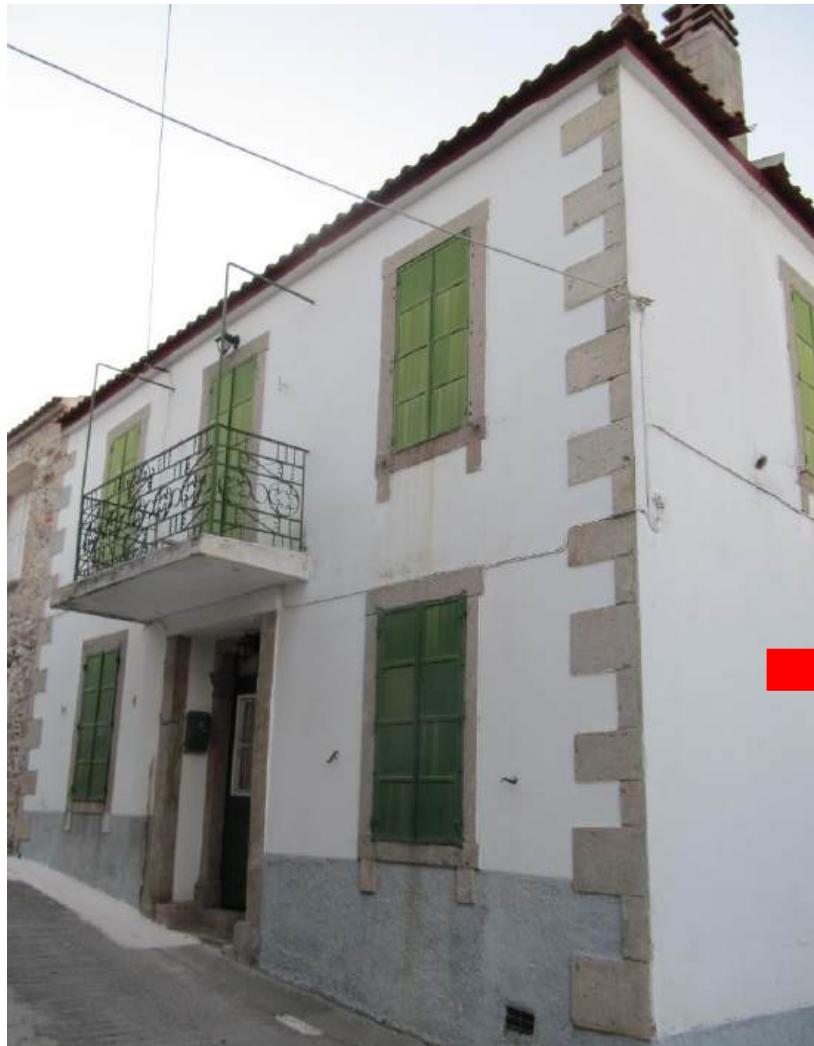
Concrete balconies rammed the top floor of the houses.

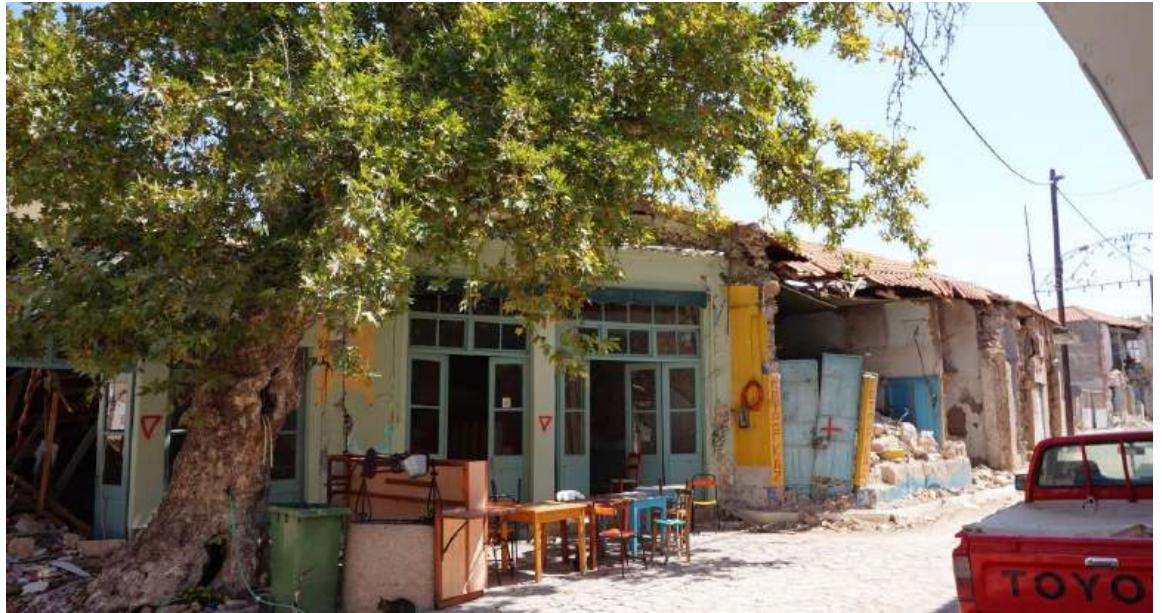
The village's traditional central spot, with the *kafenio* and the plane tree, was destroyed. So were the facades on the main streets.

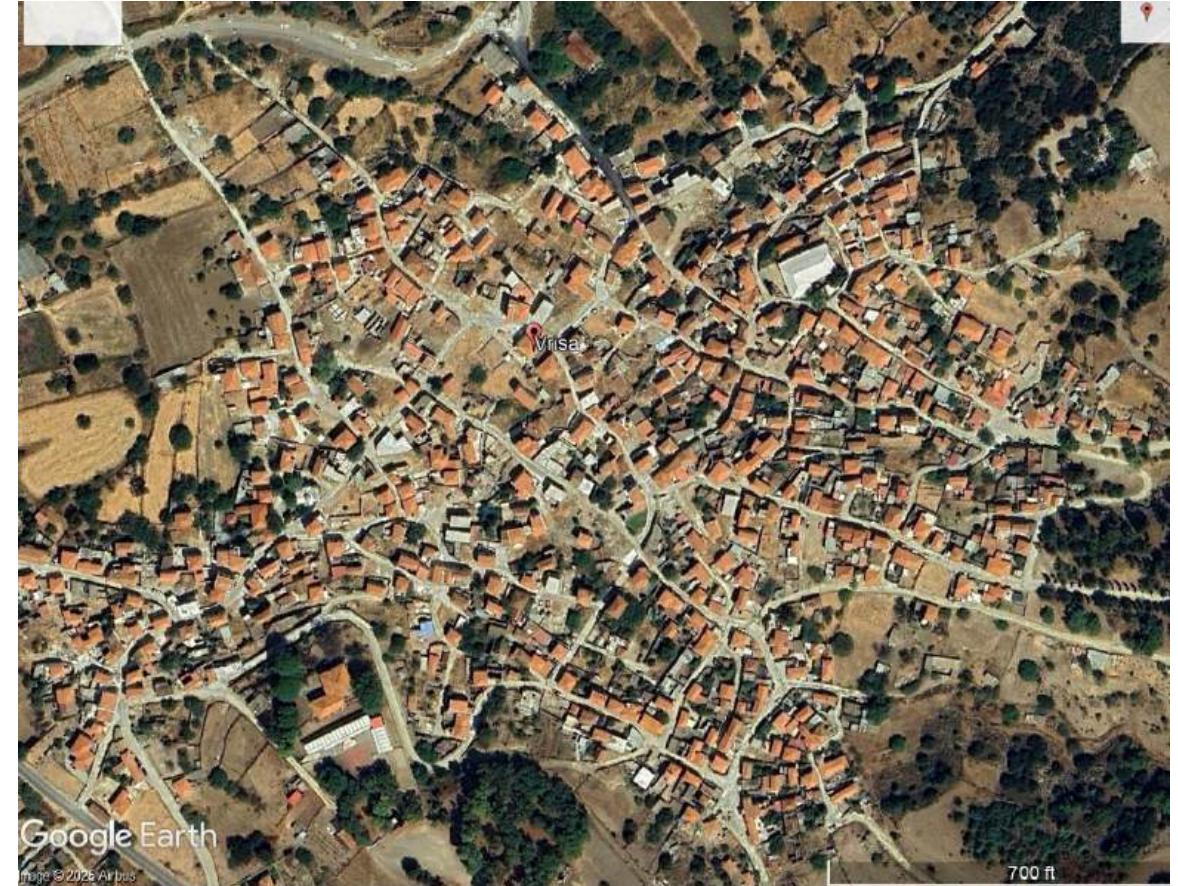
2024

Even buildings assigned yellow (to-be-repaired) had to be demolished because no measures were taken for their protection (propping, shoring).

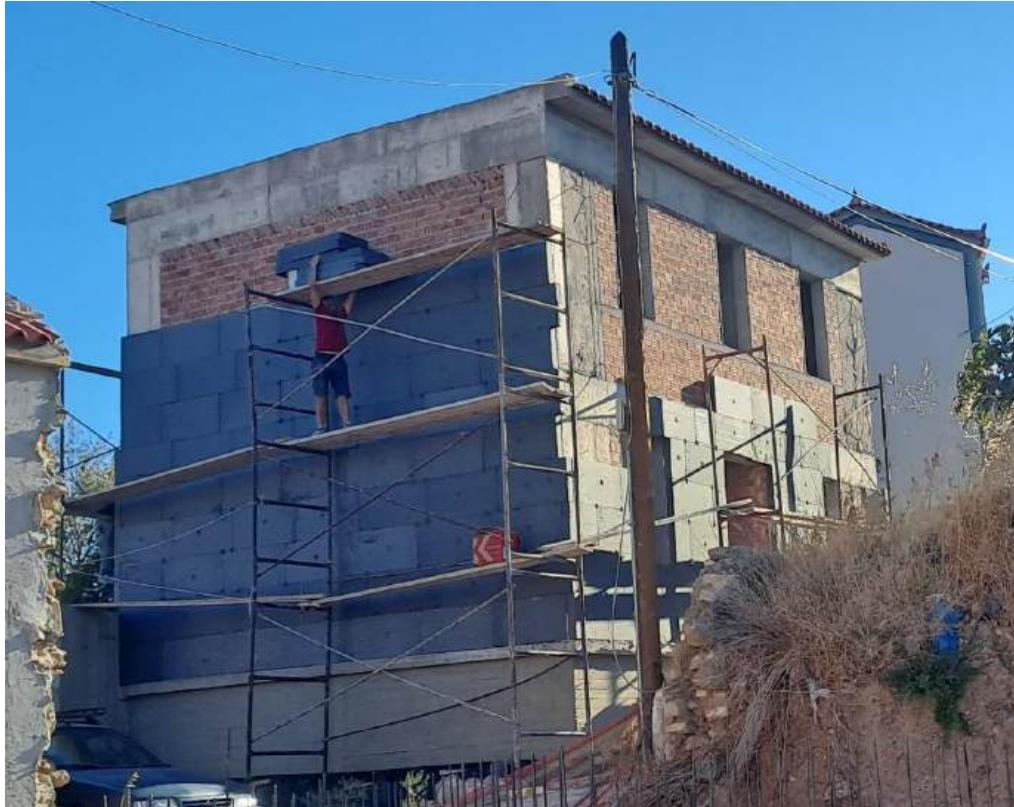
- At least “Class B” energy efficiency mandatory.
- No restriction on building materials for facades.
- Most owners and engineers chose an External Thermal Insulation Composite System.
