ANNUAL MEETING OF THE INTERNATIONAL SCIENTIFIC COMMITTEE ON HISTORIC CITIES, TOWNS AND VILLAGES
(CIVVIH) – ICOMOS

Disaster prevention in historical districts in Japan (earthquakes and fires)

Yuichi Fukukawa

STRATEGIES FOR ENHANCING HISTORIC CITIES' RESILIENCE TO DISASTERS

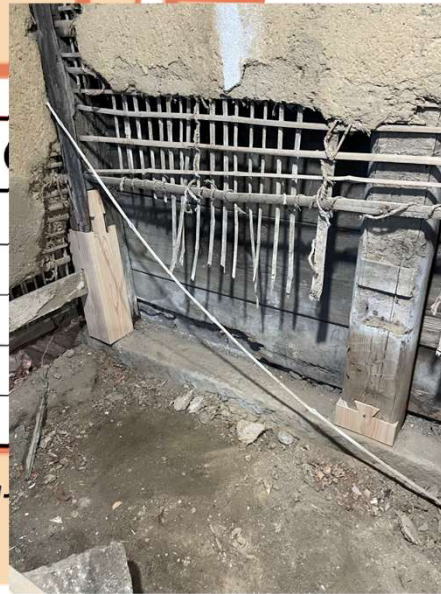
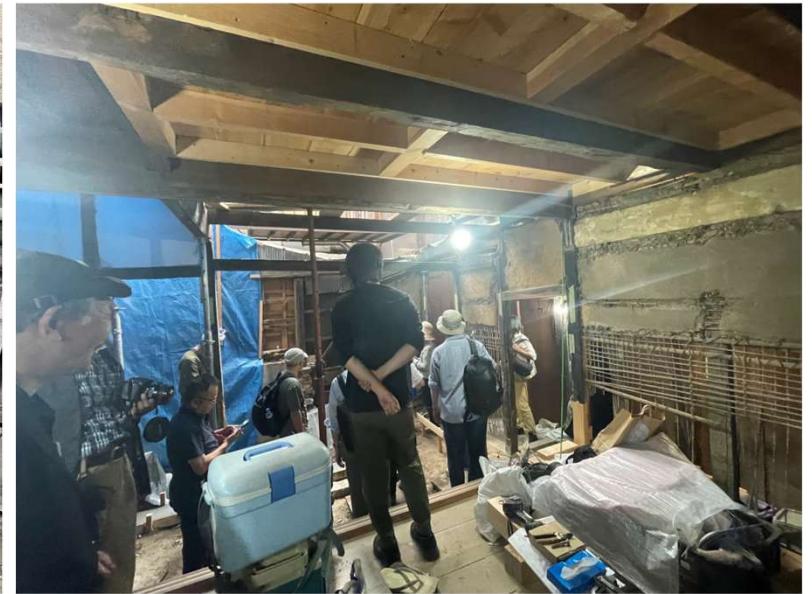
Momiji-no-koji project, Kyoto / 1. Earthquake Resistance

“Sounding” measures were taken, including repairing the foundations, replacing damaged components, and reinforcing the walls

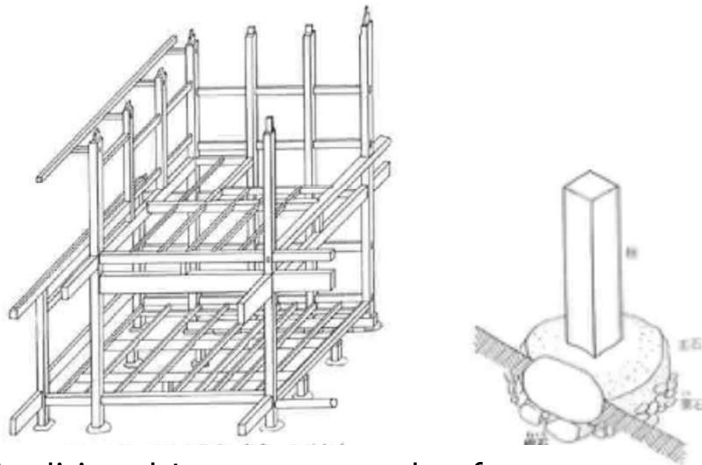
Earthquake resistance in traditional construction methods

The principle: “The most important thing is to first repair them and carry out appropriate maintenance to ensure the structure is sound. Then, a seismic assessment is conducted and based on the results, necessary measures such as seismic reinforcement are taken”

Traditional Japanese wooden frame
The foundation is not fixed

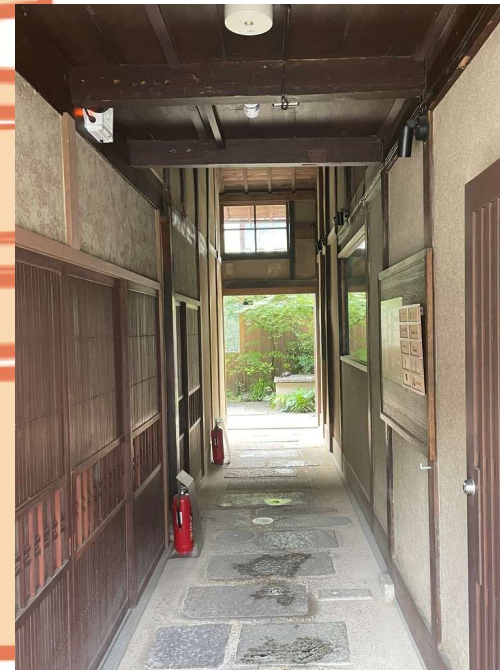
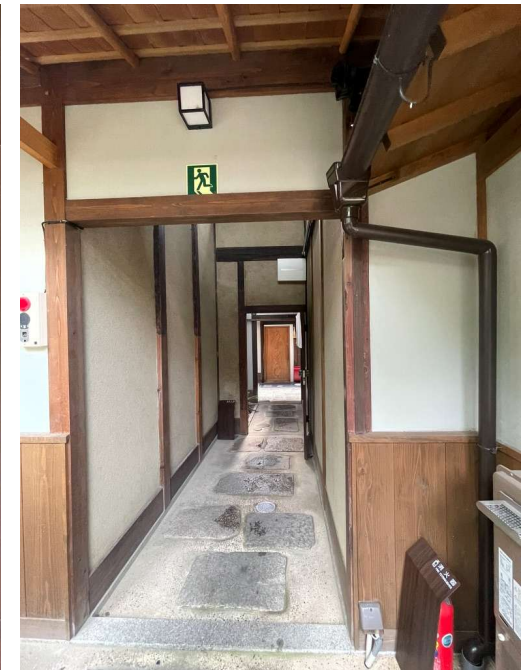
Momiji-no-koji project, Kyoto / 2. Fireproof

The fireproofing was carried out in accordance with Kyoto City guidelines without compromising the traditional design

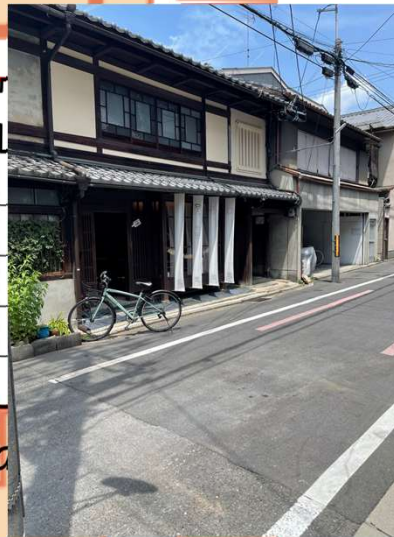
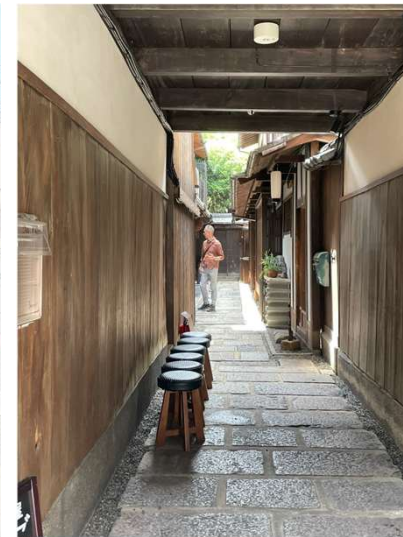
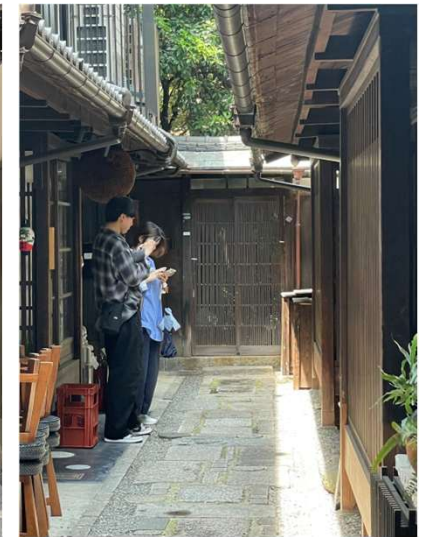
Momiji-no-koji project, Kyoto / 3. Evacuation

The biggest problem was evacuation. The building at the back was not adjacent to the 4m wide road. Fortunately, Kyoto City had a system in place that allowed multiple buildings to be built on the same site in cases like this.

A diagram showing the alternative measures to be taken in place of not having access to roads (Created by Kyoto City)

Make the exterior walls and eaves fireproof

Install fire prevention equipment in exterior wall openings

A passageway with free passage and open sky

Secondary escape route: 0.9m or more wide, reaching the road

Main evacuation route: Width 1.2-1.5m or more

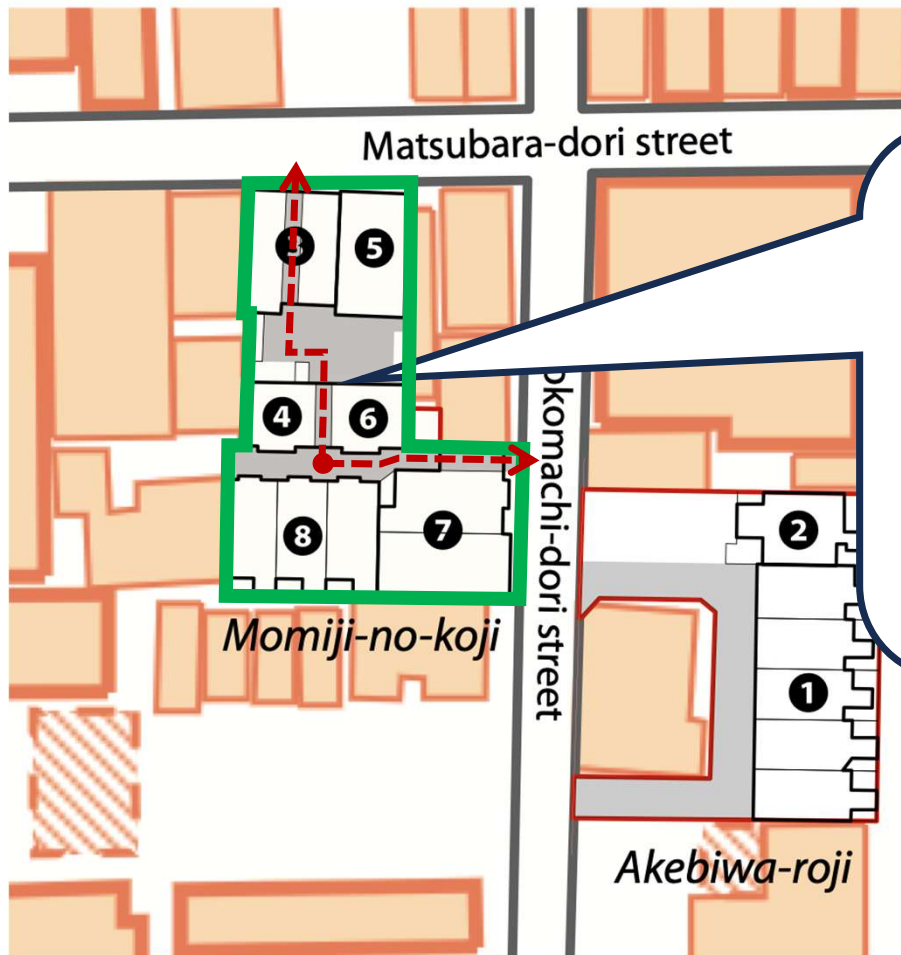
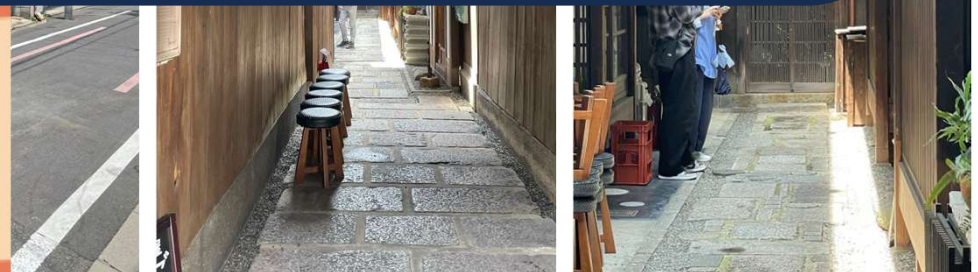
Momiji-no-koji project, Kyoto / 3. Evacuation

The biggest problem was evacuation. The

- Two evacuation routes to the road were established
- Tenants signed a disaster prevention agreement and conducted disaster prevention drills twice a year
- Interlocking fire alarms were installed
-

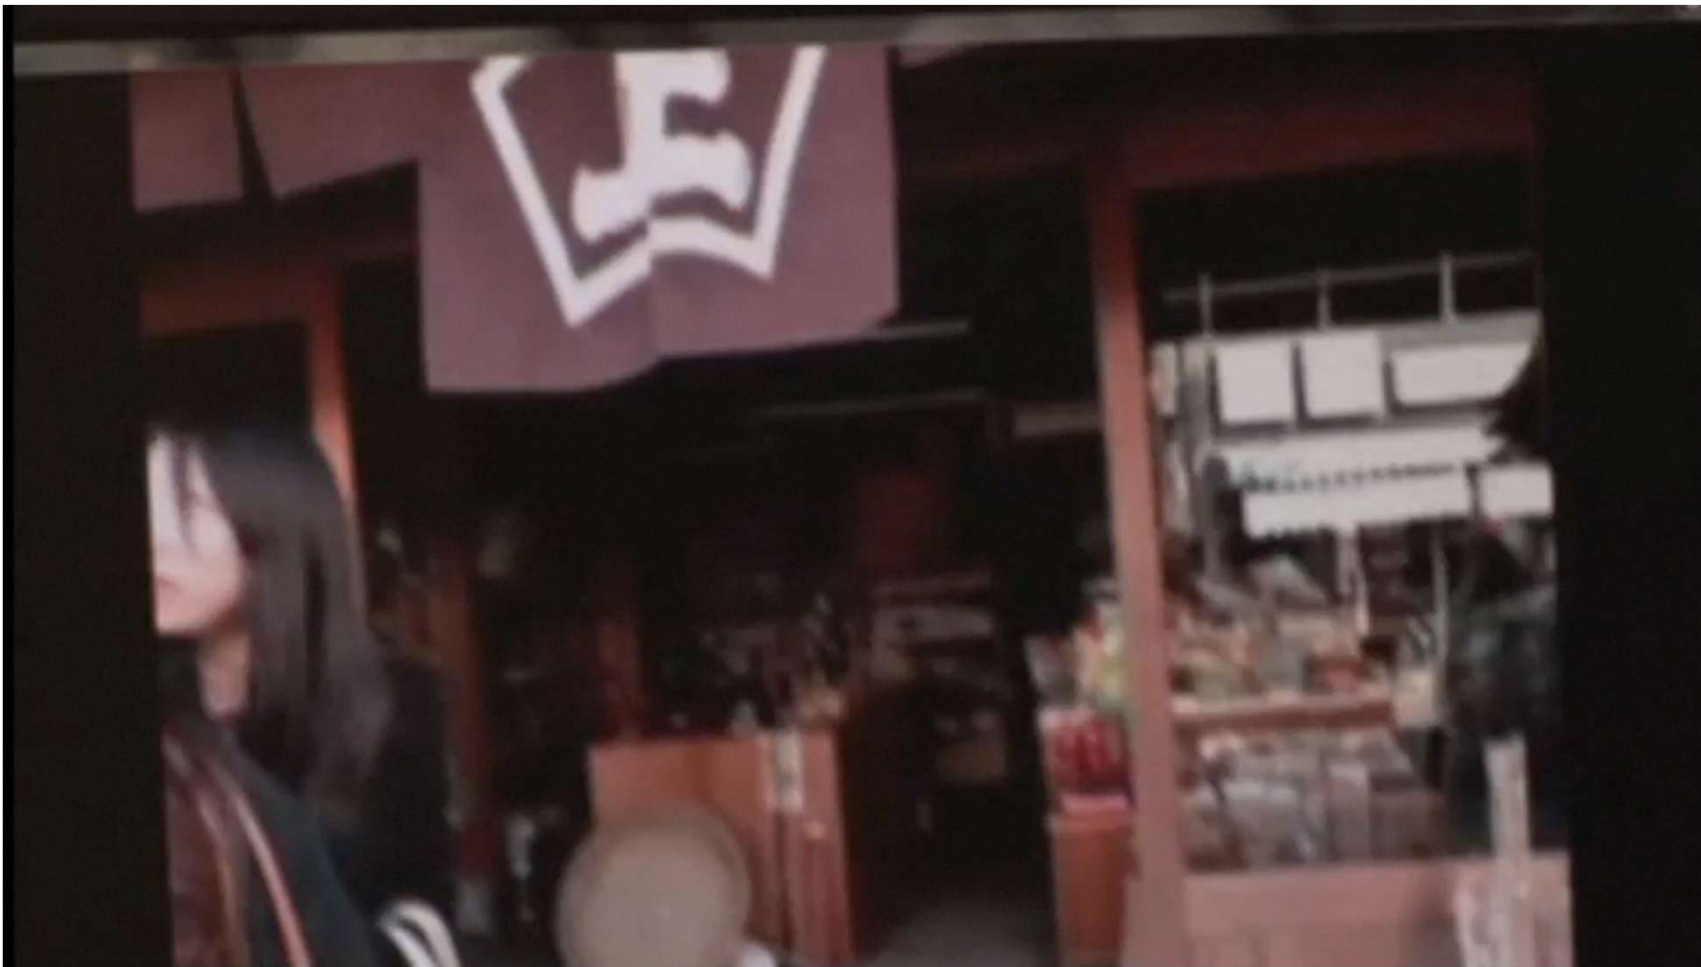
SAWARA,
Chiba pref.
March 11, 2011
Great East Japan
Earthquake

The earthquake's
strength: lower 6*

- 1) Structural
collapse was
minimal.
- 2) Earthen tiled
roofs and wall
plaster fell off.

*the Japanese
seismic intensity
scale, with 7 being
the highest

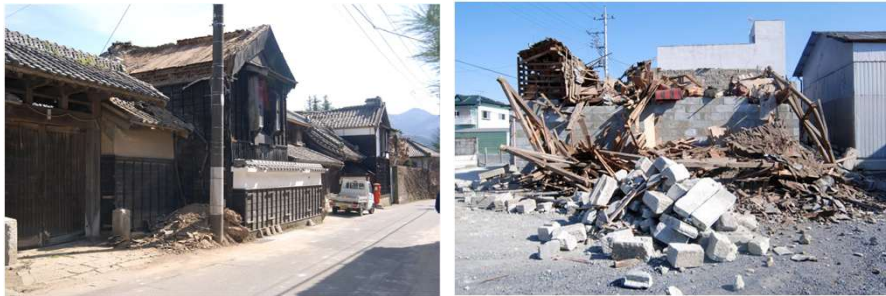
Damage to buildings in the preservation district

The strength of the earthquake and the damage to buildings were almost the same as in Sawara. a) Buildings that had been repaired were spared damage. b) Stone-built buildings collapsed

- Collapsed/Semi-collapsed: Buildings with structural damage (7)
- Buildings with damage to the roof, exterior walls, etc. (14)
- Buildings with damage only to the roof (40)
- Buildings with relatively minor damage (not requiring urgent repairs) (14)
- Buildings with no visible damage from the outside (31)

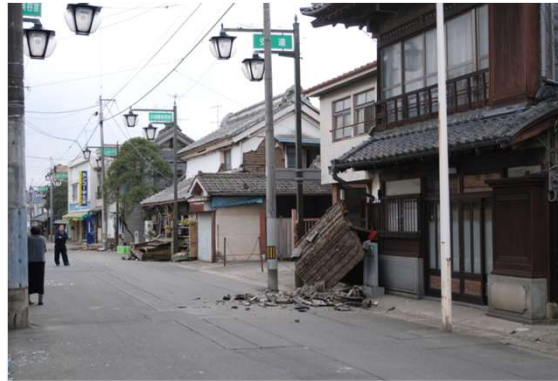
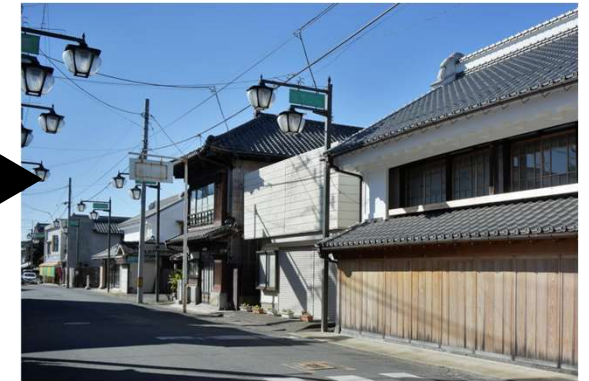
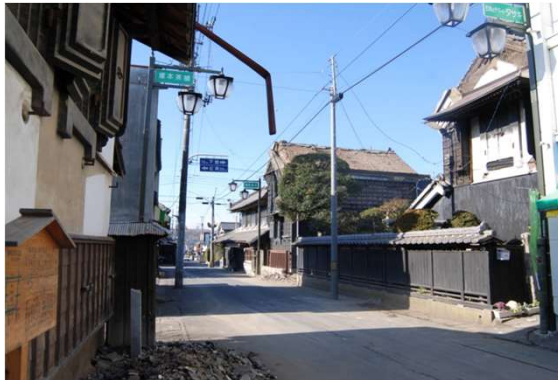
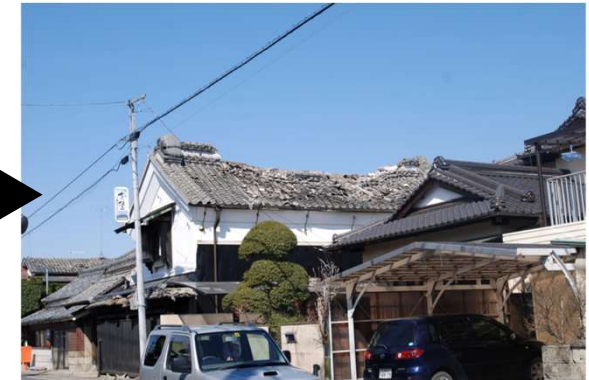
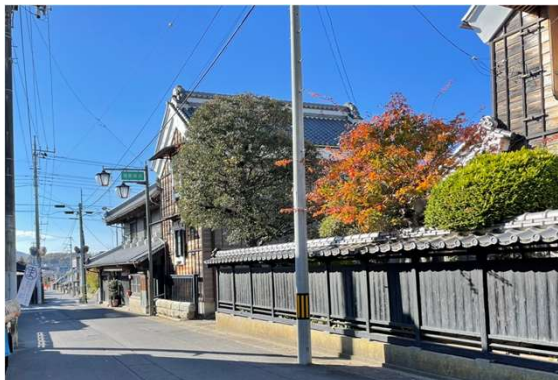
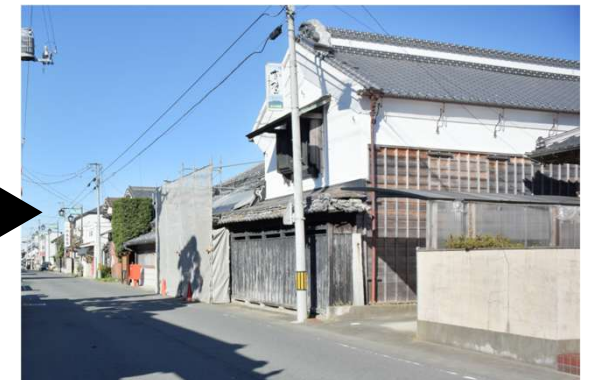
Restoration

By 2020, most of the damaged buildings had been restored without demolition. During this time, approximately 100 buildings within the preservation district and 26 listed buildings outside the district were restored as part of the disaster recovery project.
